August 2019

ASSOCIATION OF
**DEFENSE
COMMUNITIES**

FLOODED OUT

**How Stormwater Threatens the Resilience of Our
Installations...and What Can Be Done About It**

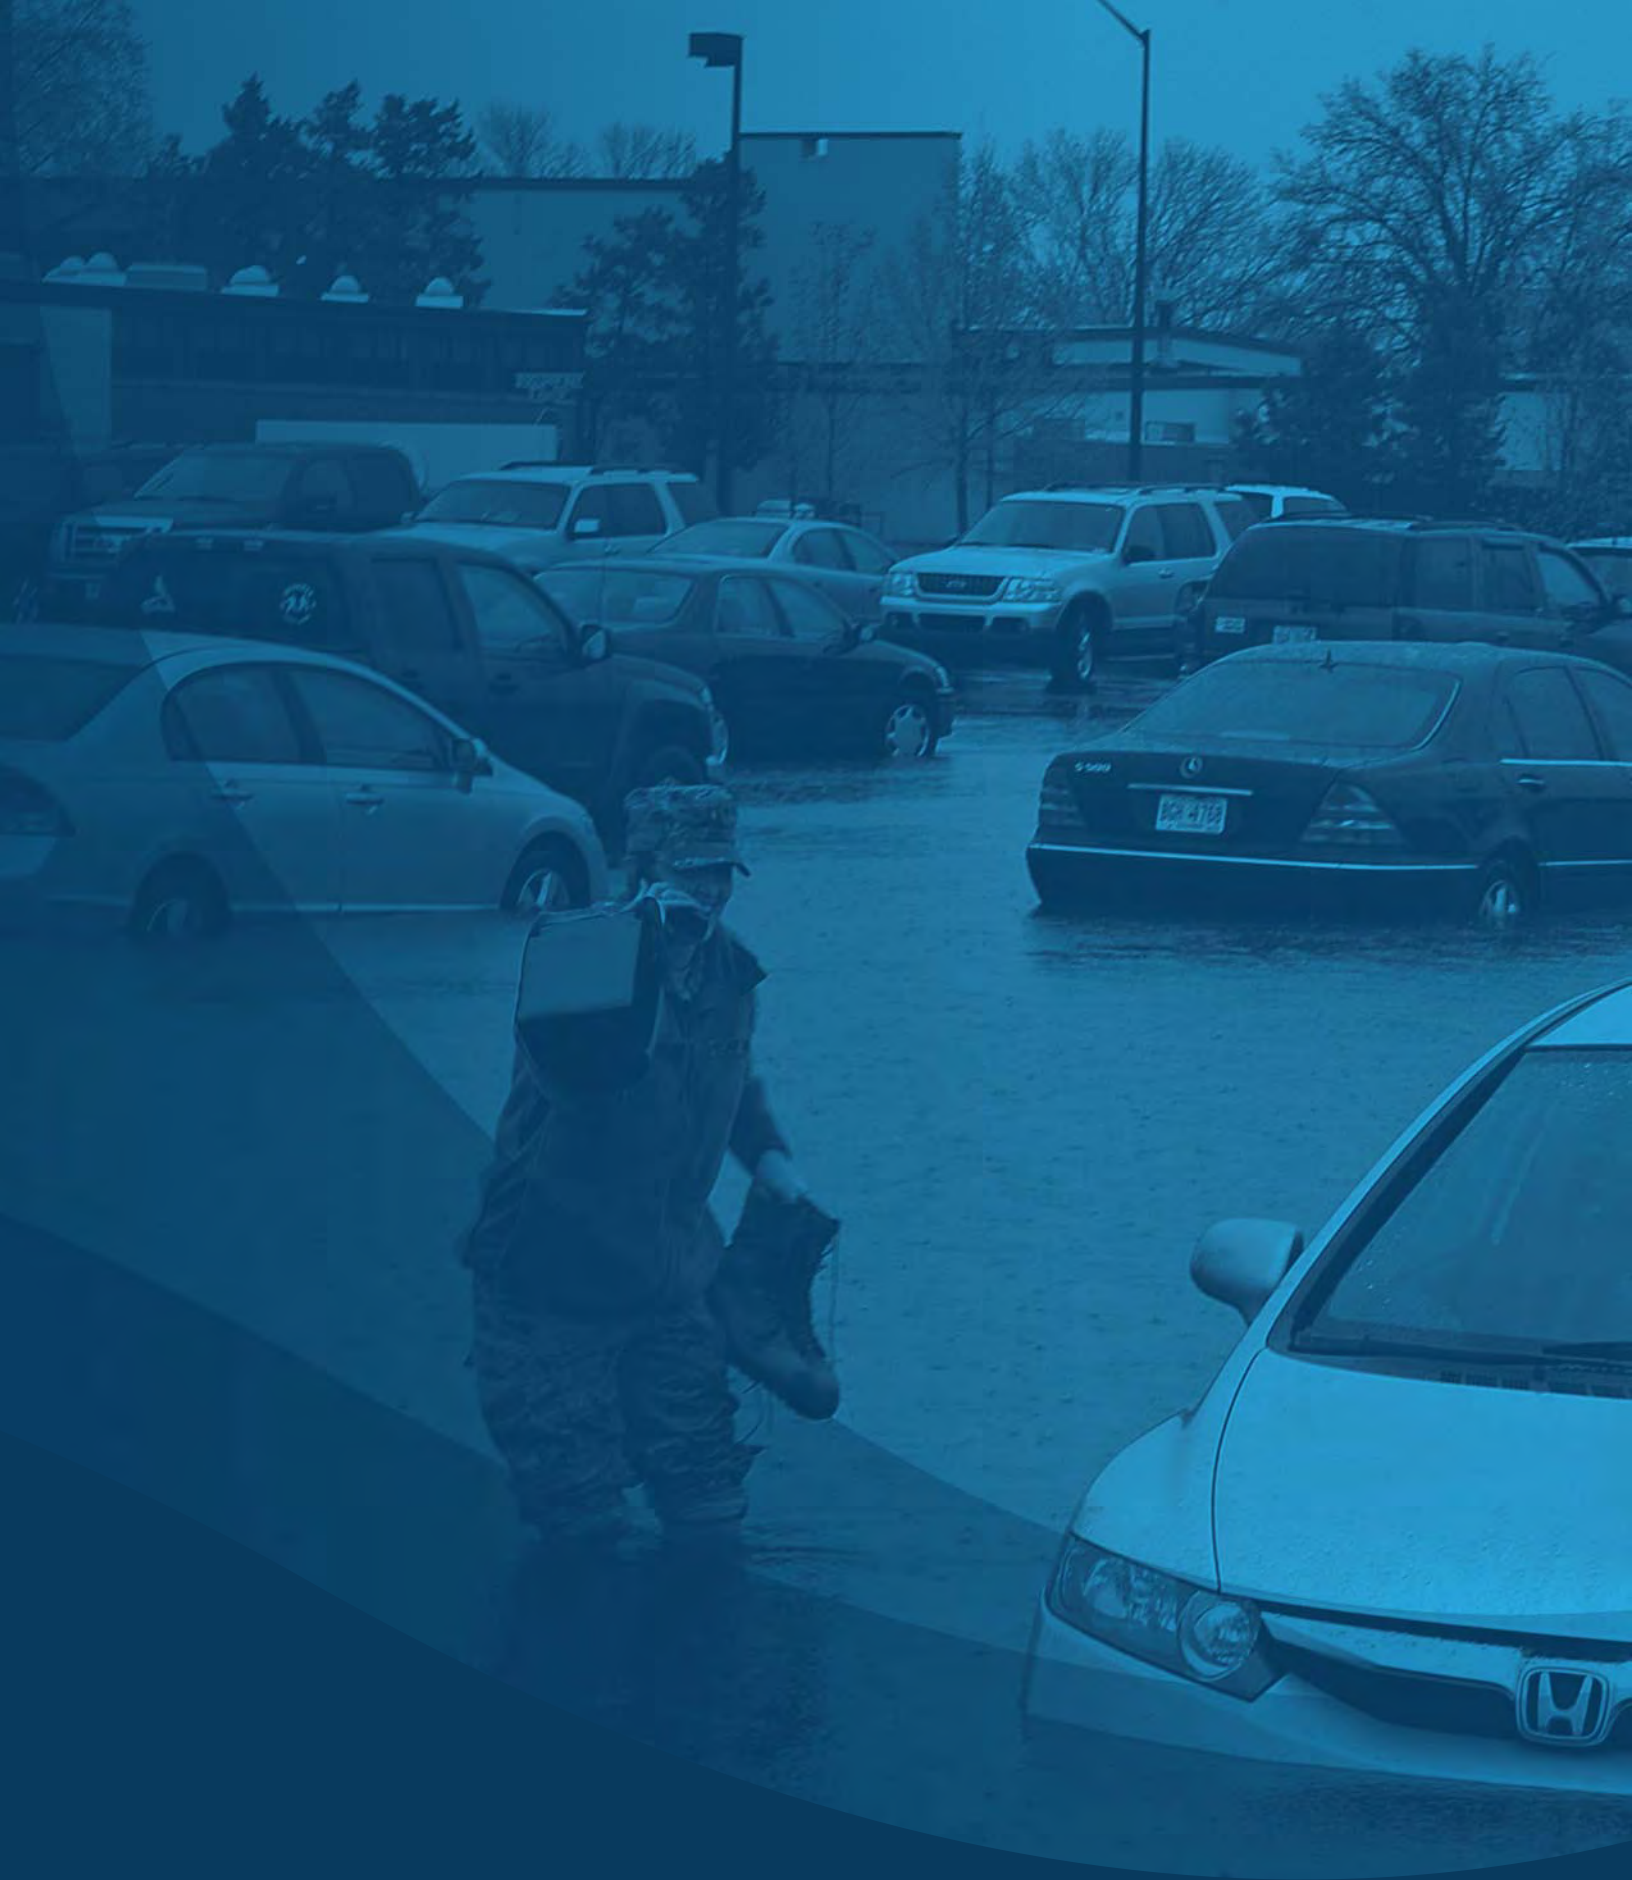
"Scott responds to flooded conditions"
Photo by U.S. Air Force Airman 1st Class Jaeda Waffer

On April 18, 2013, Scott Air Force Base, Ill., endured a heavy storm that dropped five inches of rain in under six hours, resulting in widespread flash flooding and stormwater failures across the base. The deluge so overwhelmed the stormwater system at the time that parking lots flooded, personnel couldn't reach their cars, and several key facilities were damaged.

The rainfall at the base on that day was more than it had received in the preceding two months *combined*. By late that morning the heavy rain was causing significant problems with many parking lots submerged and water damaging vehicles. Some homes in base housing began experiencing flooding and streets became impassable.

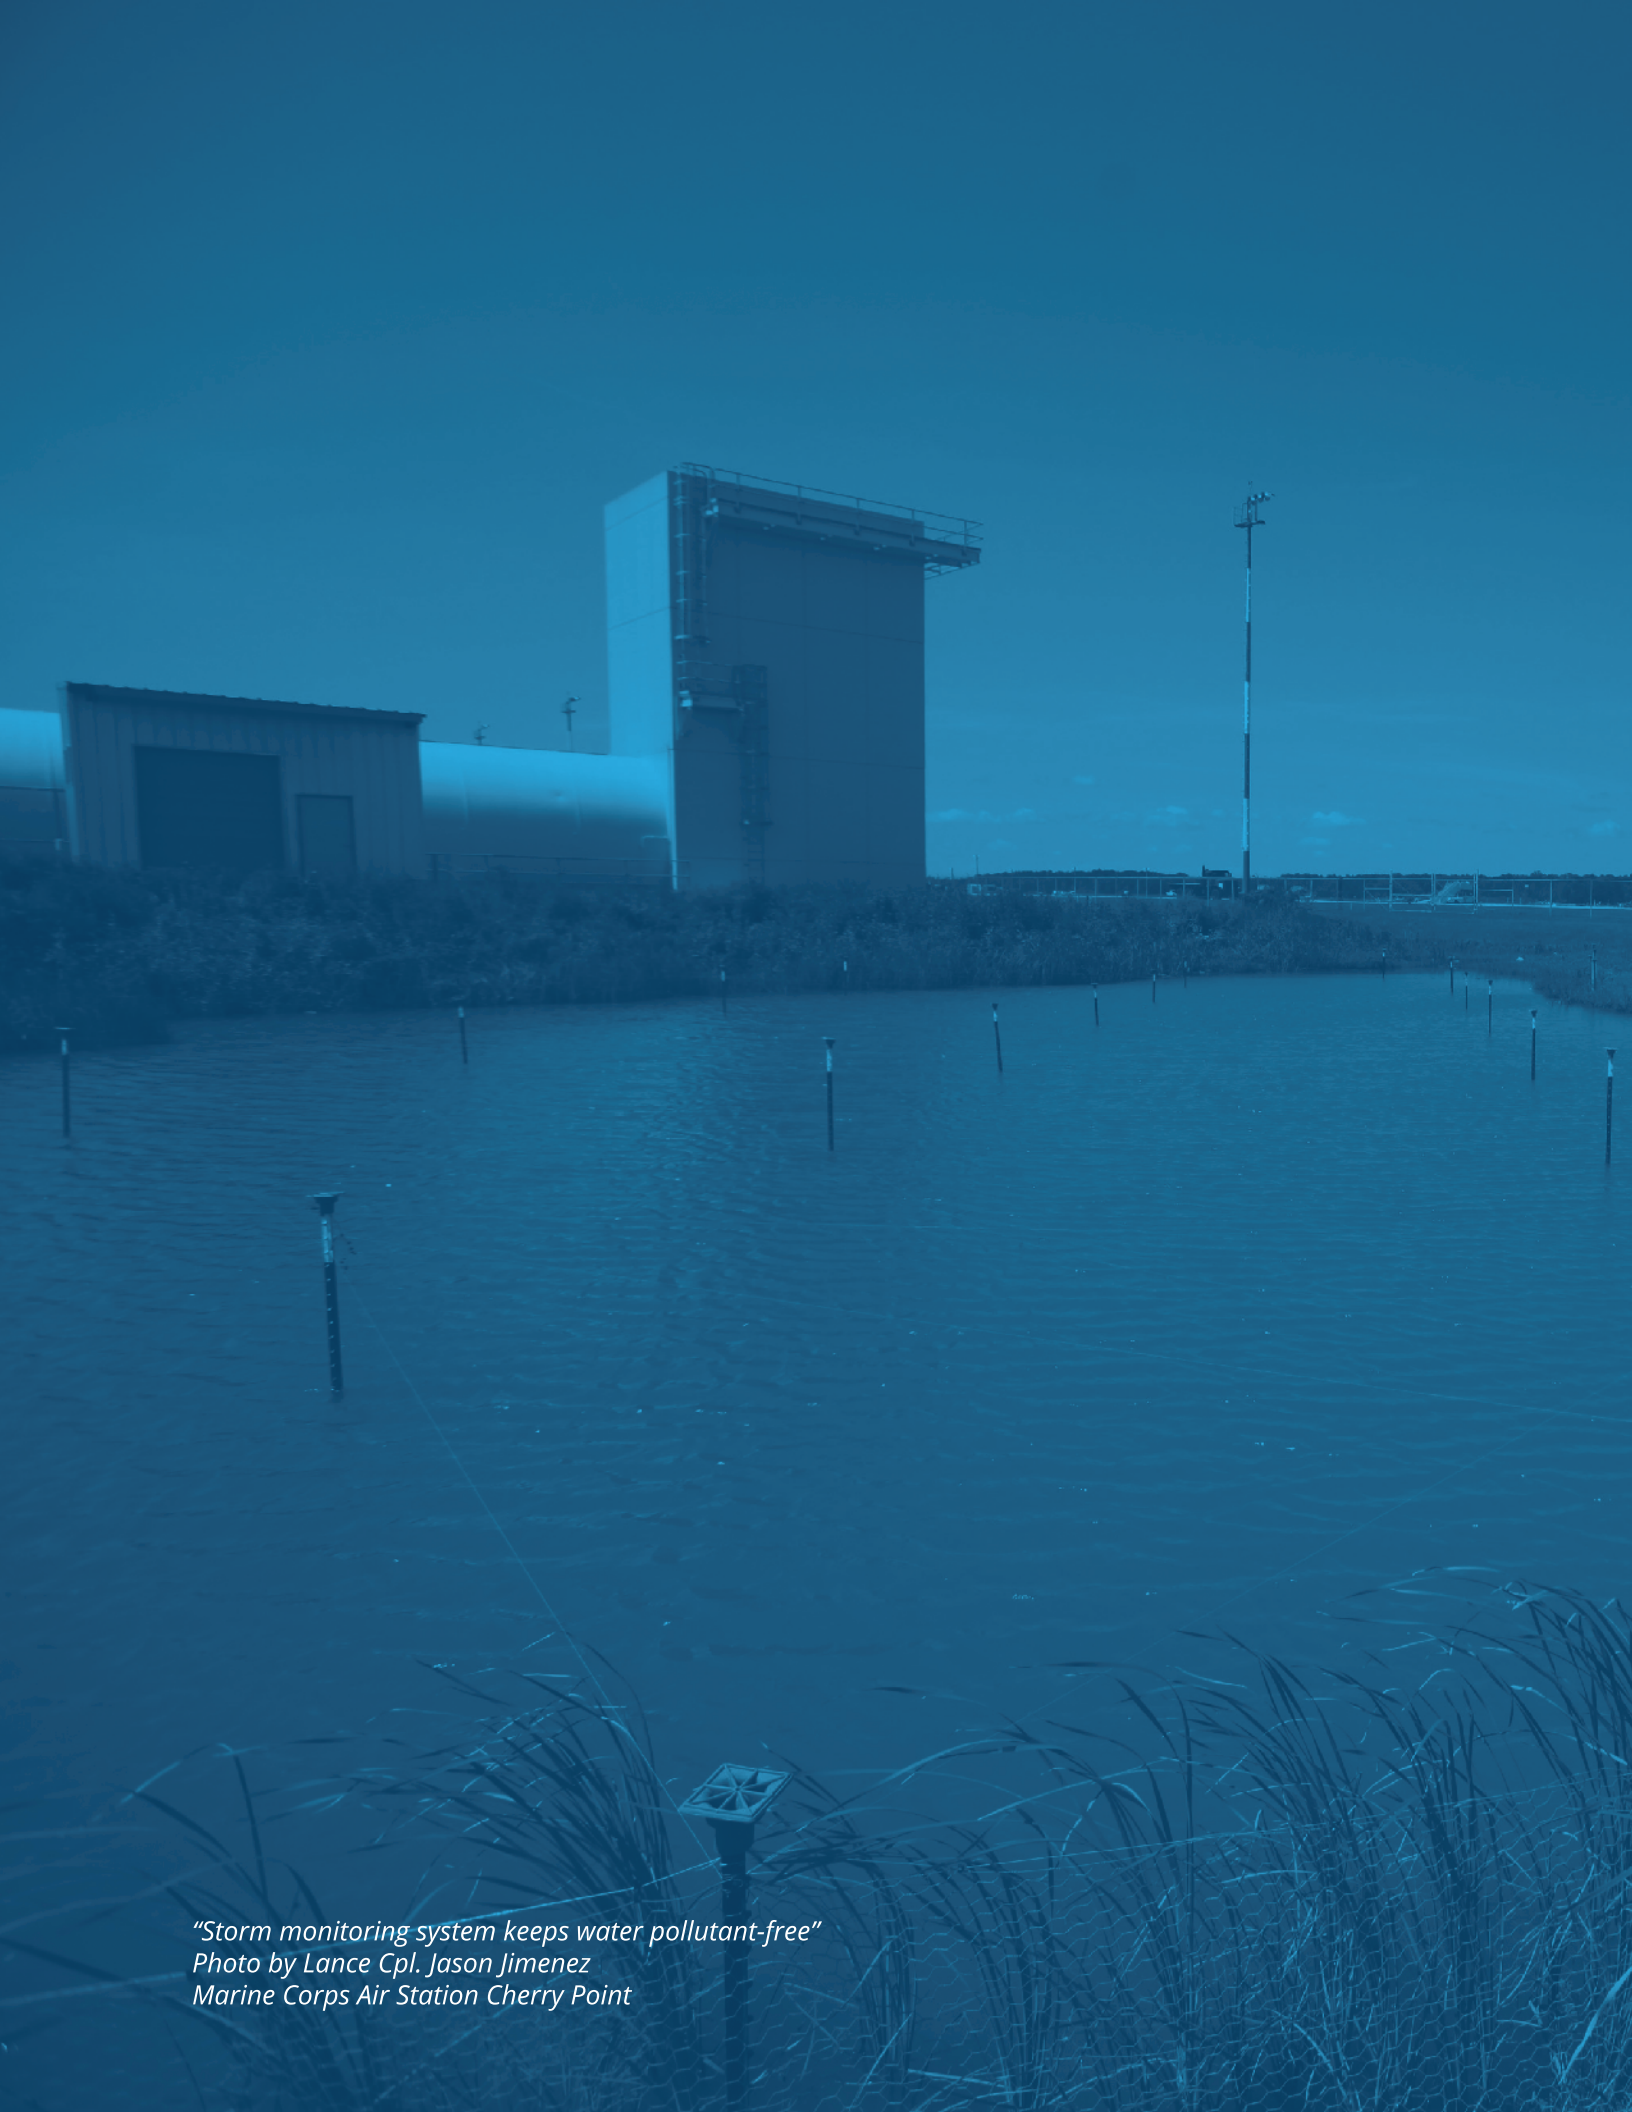
"Storm monitoring system keeps water pollutant-free"
Photo by Lance Cpl. Jason Jimenez
Marine Corps Air Station Cherry Point

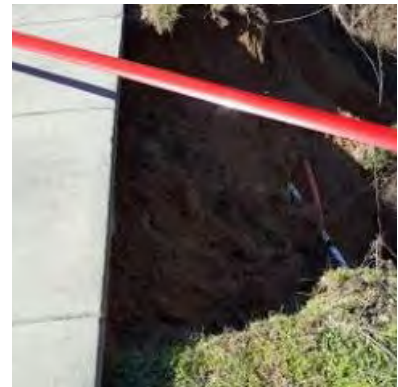
Severe Washout - This Knox Street washout occurred in Feb. 2016, causing road and sidewalk closures due to severe stormwater flow that cut this gaping ravine and created a public safety hazard. This flow also caused serious damage to utilities including water, wastewater, electricity and other installation services. The utilities were ultimately restored, but the stormwater overflowed to the point that standing water posed a health hazard. Resolution required the installation's Department of Public Works (DPW) requesting the wastewater system owner to monitor the exposed water and utilities daily.

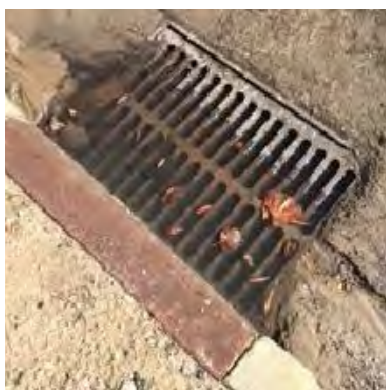
Clogged Stormwater Basins - Another example of the failed stormwater drainage system causes flooding at a key installation intersection. This sand-filled stormwater catch basin is likely clogged due to an underground pipe collapse and resulting drainage backup. More than 24 hours after flooding, the catch basin and street can remain flooded. Increasingly this major intersection and others on Fort Bragg are prone to flooding. Since funding is not dedicated to repair this intersection's drainage system, the installation posts "high water" signs for all four intersection approaches.

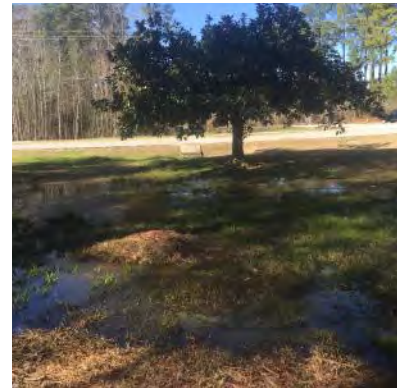
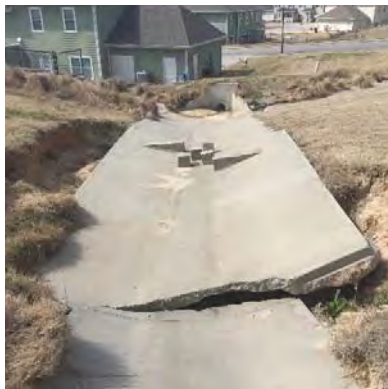
A highly visible example is the critical failure of a large storm drain box culvert that created a massive sinkhole, exposing both the pipe and storm drain box. This failure was due to underground stormwater pipes that collapsed and allowed extensive soil erosion around the drain box. This on-base stormwater drainage failure, and others like it, pose a serious threat to the safety of the families of Fort Jackson and creates a significant environmental hazard.

Stormwater damage compromised the Pierce Terrace Housing Development where sidewalks completely collapsed due to failed underground drainage. Other stormwater drainage failures near the housing development have created open roadside ditches that have shifted and collapsed due to failure of the drainage system to properly channel the stormwater flow into the culvert. The installation has installed temporary erosion control and channeling measures to try to manage the storm water flow, but these patches are short-term solutions to a long-term problem.

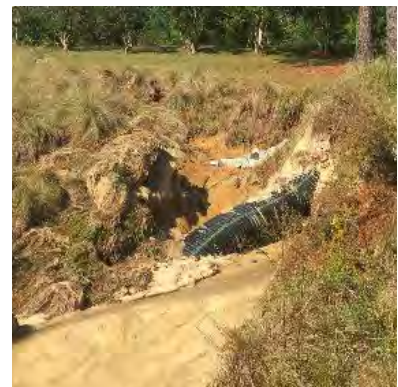
Fort Jackson's existing storm water channels are often overgrown and not maintained, preventing proper flow. Failure of the stormwater drainage has caused widespread soil erosion, including creating a large rill of unmanaged sediment. These surface hazards, and others on Fort Jackson, can increase the installation's liability by creating an unnecessary injury risk for the men and women, and families, who live and work on the base.

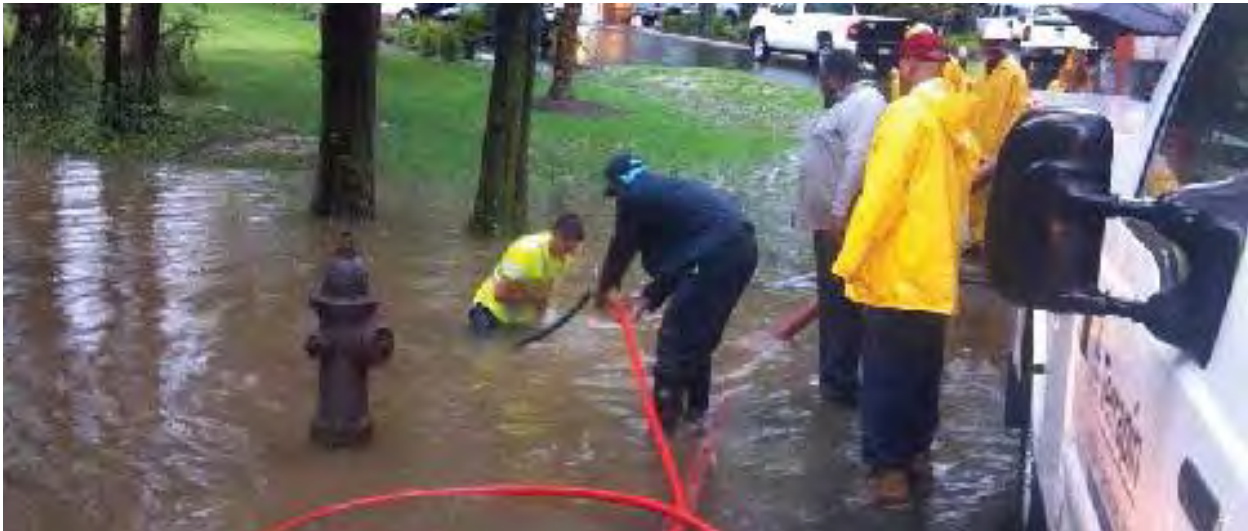
Significant and problematic recurring drainage system failures include ongoing stormwater flooding near the commanding general's house during heavy rain, which required private utility personnel and equipment to respond and repair the malfunctioning stormwater drainage. In addition to being a high-profile stormwater drainage failure, it also disrupts routine operations and impairs installation readiness.

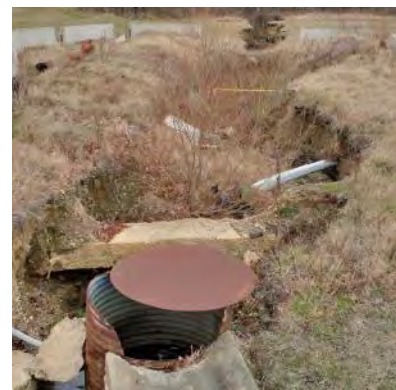
Another site of the drainage system's failure is a stormwater inlet (shown) that deteriorated and the outflow pipe has fully collapsed, causing significant erosion and soil washout. The land surface, once level, completely washed away creating a steep, elongated crater. The soil washout was so severe it ultimately exposed the stormwater inlet's concrete casing and the downstream stormwater piping. The unmaintained stormwater washout has now existed long enough for vegetation to flourish.

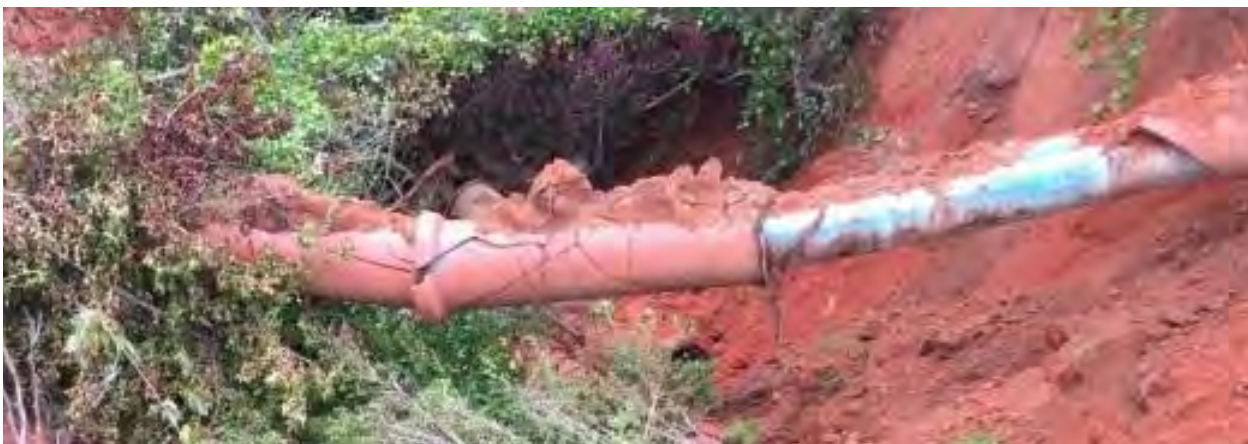
An alarming example at Fort Rucker features a fully exposed and sagging sewer main that had serious damage after a 60-inch stormwater drain failed during heavy rains, resulting in a 10-foot ravine being cut downstream caused by excessive stormwater erosion that left the sewer main exposed and suspended over the ravine.

The exposed and suspended sewer main showed signs of potential rupture, but it could have been much worse if the sewer main had not been recently reinforced with vitrified clay (VC) piping, providing additional support and protection from the unexpected stormwater distress.

Though the VC piping was broken and the sewer main was clearly distressed, worse damage could have resulted in unknown quantities of sewage flowing into the ravine and downstream with the torrent of uncontrolled stormwater.

The drainage failure required quick response of private utility partners to permanently repair the damage. Failure of the exposed sewer main was imminent, so by-pass pumping was installed to protect the environment and prevent sewer overflows. The by-pass solution was also installed as a lift station with a mission alarm system to provide alerts in the event of potential overflow. The exposed sewer main was then ultimately removed to allow repair of the failed storm drain and relocate it downstream from the sewer main.

Final private utility response to the incident involved full repair of the failed storm drain and reinstatement to proper grade, and installation of a new 21-inch sewer pipe and a manhole in the eroded area. The private utility work to repair the failed storm drain and the eroded area was completed in approximately three weeks.
